TS-PIC-84092
October 1984

Site Analysis Millington Asbestos Dumps Morris County, New Jersey

EPA Region 2
and OERR

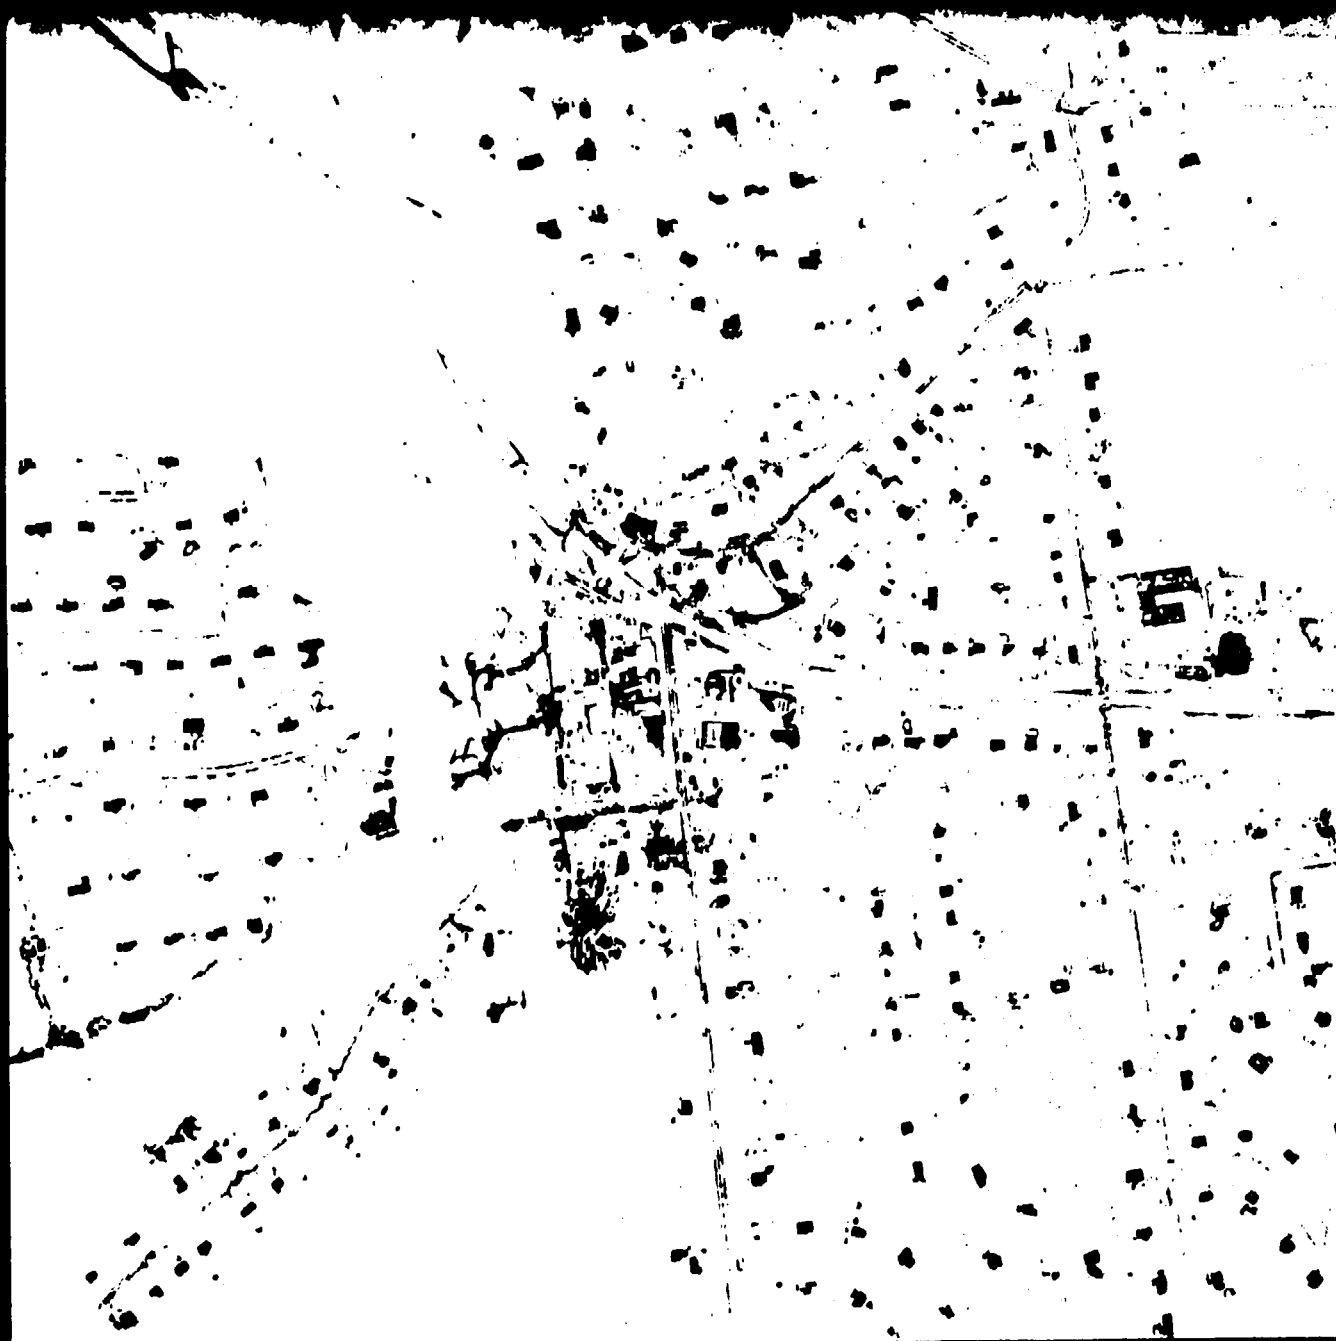
FIGURE 10
MILLINGTON ASBESTOS DUMPS

- 1983 - (Fig. 10) Possible recent disposal activity indicated by probable light-toned mounded material visible in clearings in the thick vegetation cover on fill area. Disturbed ground in graded area east of fill area may indicate possible renewed disposal activity.
